DEFECT DEFINITIONS AND CORRECTIONS

SUGGESTED CORRECTIONS FOR WARE DEFECTS

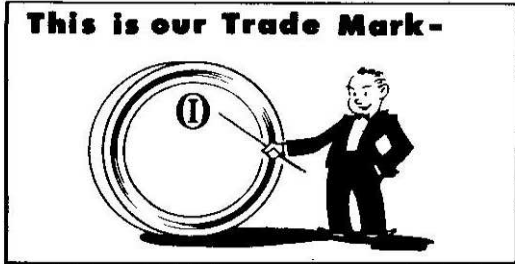
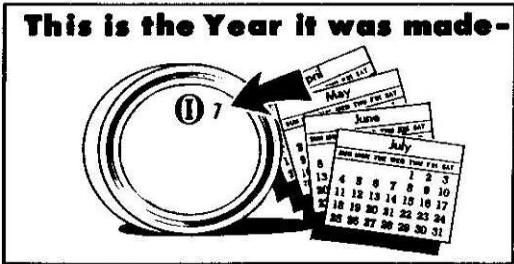
Trade Mark - Practically every product made is identified by a name or trade mark of the manufacturer. Owens-Illinois uses the O-I design as the trade mark for its glass containers.

Year Date - For statistical reasons it is important that the glass container be identified. The last digit of the year date is placed to the right of the trade mark.

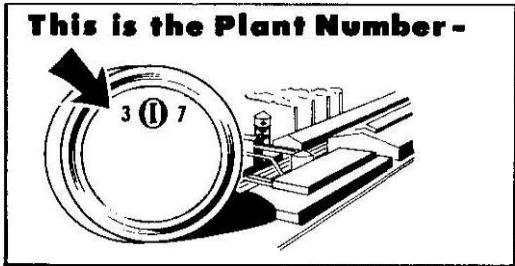
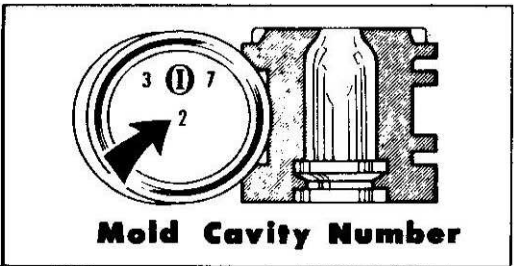
Plant Number - Owens-Illinois has other plants making glass containers and each of these plants has a number which assists in its identity. This number is placed to the left of the trade mark and identifies the plant making the glass container.

Mold Cavity Number - This number is found below the trade mark and its purpose is to identify the mold from which it was made. This aids in locating a mold which is not producing good glass containers.

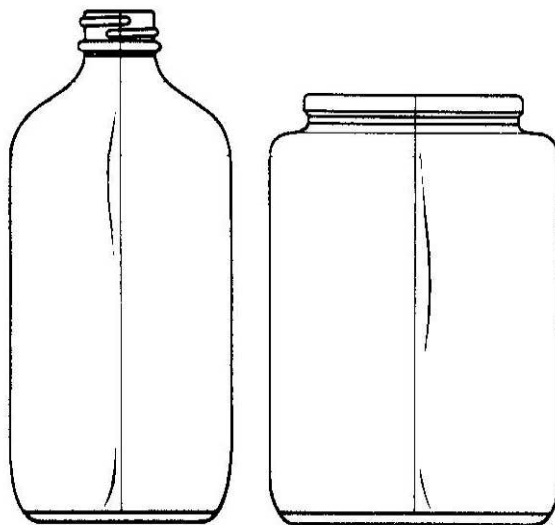
**EXAMPLES OF
GLASS CONTAINERS**

narrow neck

wide mouth

There are many types of glass containers... milk bottles, liquor bottles, food jars, etc., most of which we are familiar. Here are two examples... the wide mouth or food jar and the narrow neck or beverage bottle.

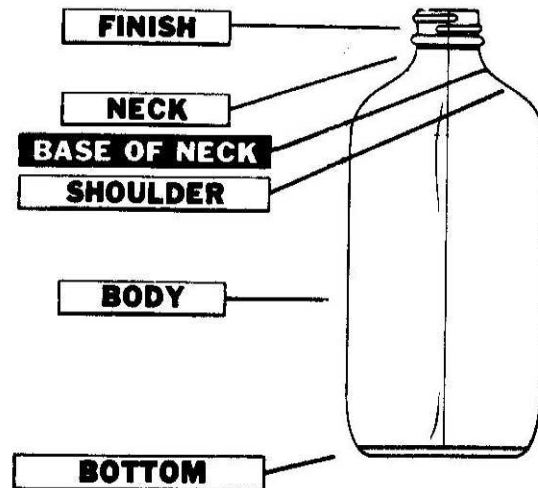
PARTS OF A BOTTLE

To better enable you to become a good operator it is important that you first understand the parts of a bottle. The bottle, like most other items, is divided into identified parts which are all related to each other.

The Finish - is that definite section located at the uppermost part of the bottle or container. It is that portion of the container where the cap or sealing device is placed and contains the opening or mouth for filling and emptying.

The Neck of the bottle is that portion which extends from the parting line of the Finish to the sharpest curve at the base of the neck.

The Shoulder of the bottle extends from the base of the neck to the straight part or body of the bottle.

The Body is that portion of the bottle which holds the product for which it was made.

The Bottom is that portion of the bottle on which it rests when in an upright position.

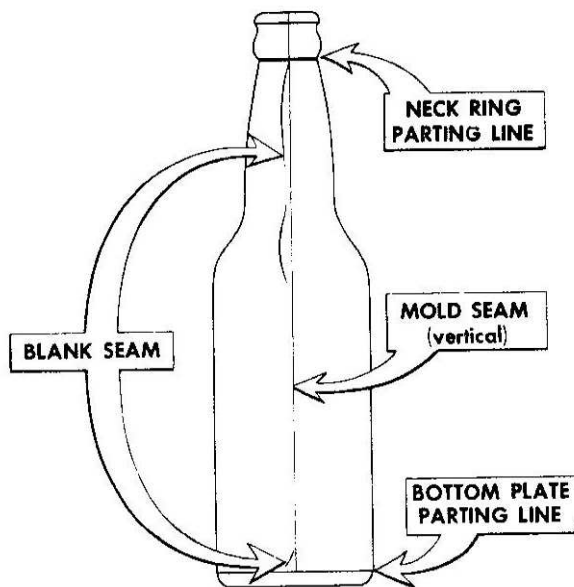
PARTING LINES & SEAMS

To produce or make a glass container we must use a blank mold, neck ring, body mold and bottom plate. Where the neck ring and body mold join we have the "neck ring parting line". Where the body mold and the bottom plate join we have the "bottom plate parting line". The body mold is made of two separate sections which open and close around the container as it is formed. Where the two sections join each other we have the "mold seam" which always runs vertical on the length of the container.

The blank mold operates similar to the body mold but preforms the hot glass for better distribution in the body mold. Where the two sections of the blank mold join we have the "blank seam" which is sometimes visible on the finished container.

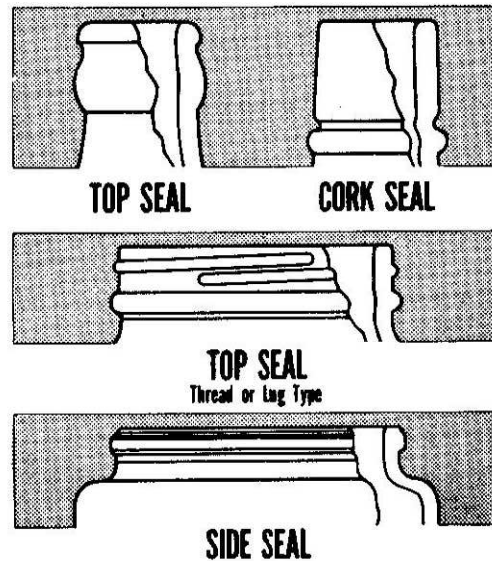
TYPES OF FINISHES

The finish is the most important part of the glass container and must be free of serious defects in order to guarantee proper sealing or capping of the bottle by the customer. The most common types of finishes are:

1. **Top Seal** - Sealing surface is on top of finish and used mostly for beverage bottles.
2. **Cork Seal** - Sealing surface is inside the finish. It has a variety of uses such as wine bottles, prescription bottles, etc.
3. **Top Seal - Thread or Lug** - sealing surface is on top of finish and screw type closure or cap is used. It also has a variety of uses such as food containers, liquor bottles, etc.
4. **Side Seal** - Sealing surface is on the side of the finish and the cap or closure is pressed on to seal the product. This type finish is used for many food products, baby food, vegetables, fruits, etc.

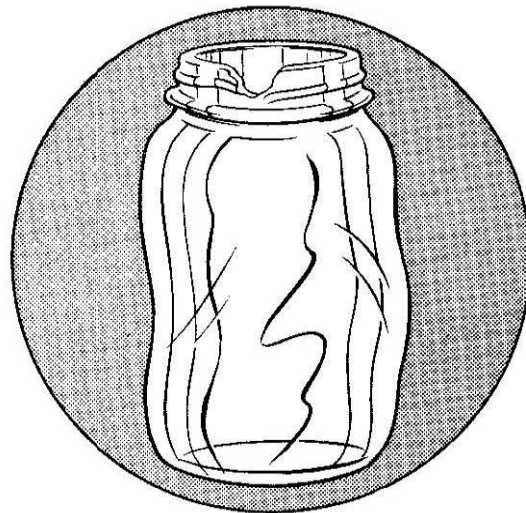
FREAKS

Freaks are just what the name implies. They are bottles so badly mis-shapen or un-formed that they could be seen 25 feet away. But surprisingly enough, we receive complaints on freaks.

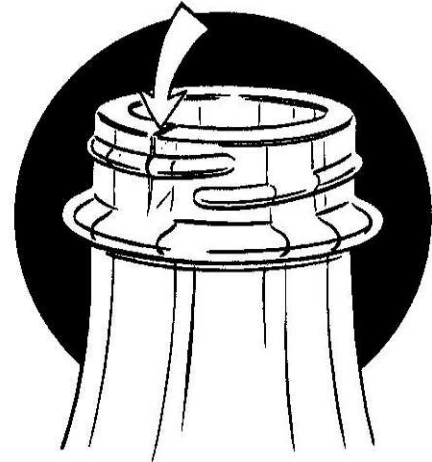
SPLIT FINISH

A vertical crack that runs from the top of the finish downward toward the neck. It can be found by catching the reflection of the light while turning the bottle. It may lead to spoilage on vacuum packed or processed foods and can cause leakers on other types of containers. CORRECT AT ONCE.

- a Too much settle blow
- b Final blow coming on before blow head is down
- c Plunger contact time too long
- d Plunger too cold

- a Blow head too shallow
- b Plunger too cold
- c Too much wind on nozzle over mold
- d Takeouts need wrapping

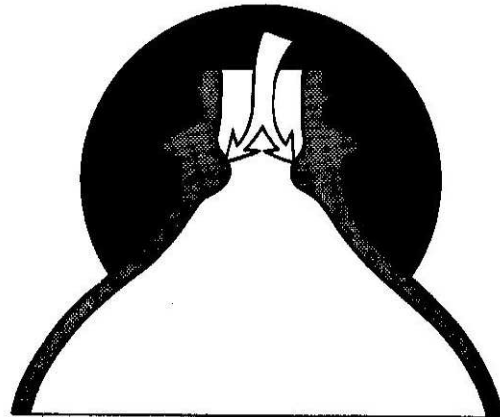
CHOKED NECKS

A narrowed or obstructed neck opening. Our customers fill bottles mechanically with filling tubes entering through the neck of the bottle at a high rate of speed. If the opening is smaller than the filling tube, the tube or bottle may break. This will jam the filling machine and cause lost time. All narrow neck bottles should be checked with proper plug gauges. When bottles are found that will not allow the plug gauges to enter the bottle opening, they should be CORRECTED AT ONCE.

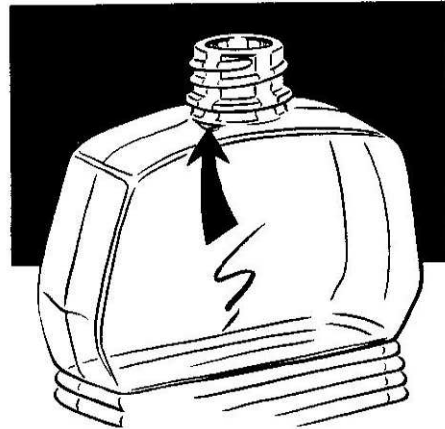
CHECKED BASE

A closed crack at the base of neck, where the neck joins the shoulder. This can be detected by catching the reflection of light while turning the bottle. A checked base is usually found on the seam and whether it is the size of a pin head or extends around a large part of the neck, it should be CORRECTED AT ONCE.

- a Mold opening too hard
- b Bottom plate too high or too low
- c Worn mold arms
- d Too much wind on molds
- e Molds too hot
- f Too much final blow pressure
- g Blow head too tight
- h Wrong internal cooling valve adjustment

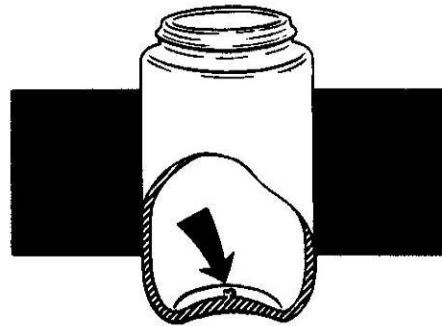
STUCK GLASS

Stuck glass is a particle or particles of glass stuck to the inside of bottle. It can be found by rolling the bottles and may be located in any part of the bottle. It is most common to wide mouth ware (baby food), but is also found in other type ware. It is most serious for obvious reasons and should be CORRECTED AT ONCE.

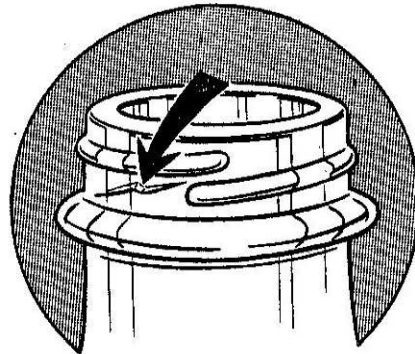
CHECKED FINISH

A checked finish is a closed crack in the finish of the bottle. To find this catch the reflection of the light while rolling the bottle.

- a Wrong plunger cylinder adjustment
- b Neck ring out of alignment
- c Too much settle blow
- d Improper ring arm cushioning
- e Baffle down too hard
- f Blow head out of alignment

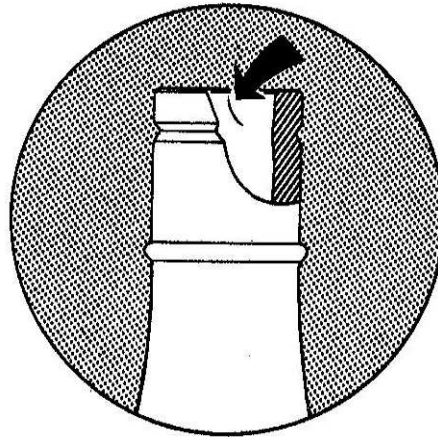
CORKAGE CHECKS

A vertical check inside the finish which lets air go between cork and finish. This may cause spoilage of the product.

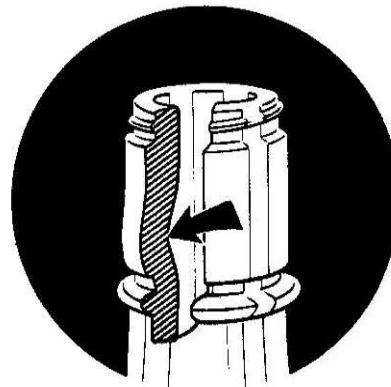
BULGED FINISH

The finish is bulged or pushed out.
This may prevent good capping which
could permit product spoilage.

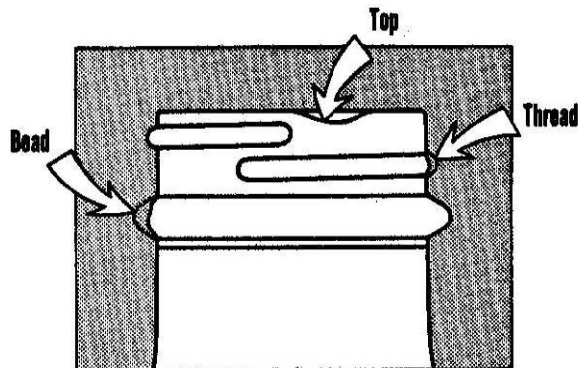
Top · Bead · Thread

The top of the finish, the lug or the thread not blown to full size.

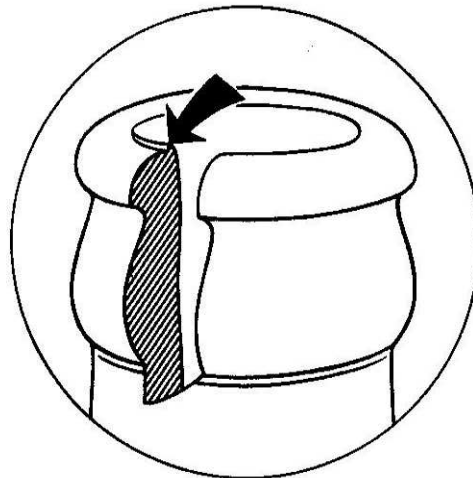
OVERPRESS ON FINISH

A rim of glass extending up from the inside edge of the finish.

- a Glass getting in blank before plunger is in position
- b Worn plunger plate
- c Plunger mechanism too low

- a Plunger diameter too small
- b Plunger match with ring too loose

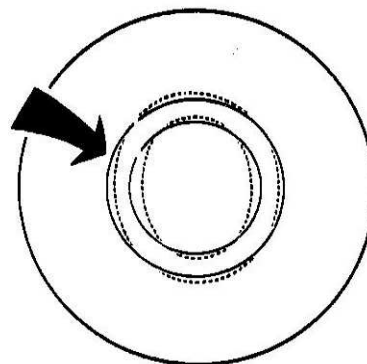
OUT OF ROUND FINISH

Finish that is not within specification limits. Gauges are furnished to check for this defect.

- a Not set hard enough, more settle blow
- b Blow head not centralized
- c Plunger contact too short
- d Neck ring too hot
- e Improper takeout timing or setting
- f Poor transfer

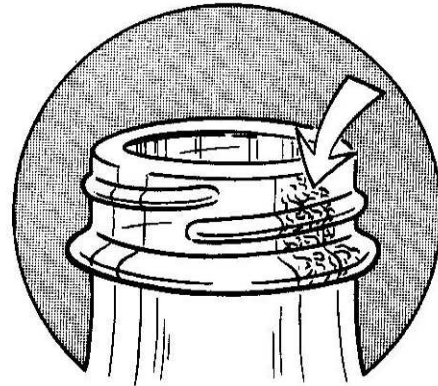
DIRTY FINISH

A dirty finish looks scaley and may have black spots on it. We must look for two things, first, that it is o.k. in appearance and second, that it is not "pitted" too badly to interfere with the sealing surface.

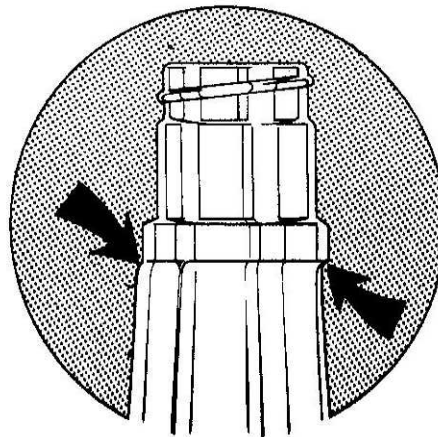
OFFSET FINISH

This is a finish that is offset or shifted to one side.

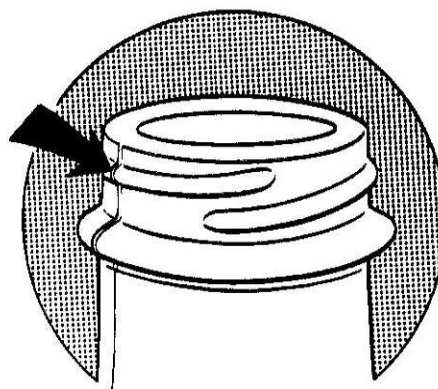
NECK RING SEAMS

This is a rim or edge of glass protruding outward from the neck ring halves.

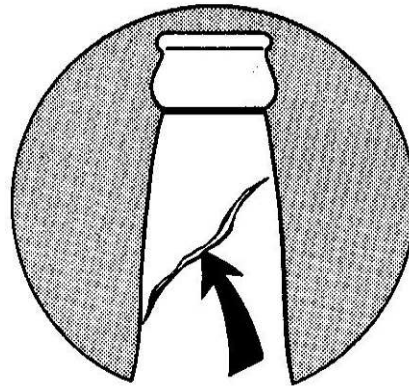
TEARS ON NECK

This is an open mark on the neck of the bottle.

- a Wrong plunger cylinder adjustment
- b Improper transfer into mold
- c Too long a settle blow
- d Loose collar on plunger cylinder
- e Too long a counter blow

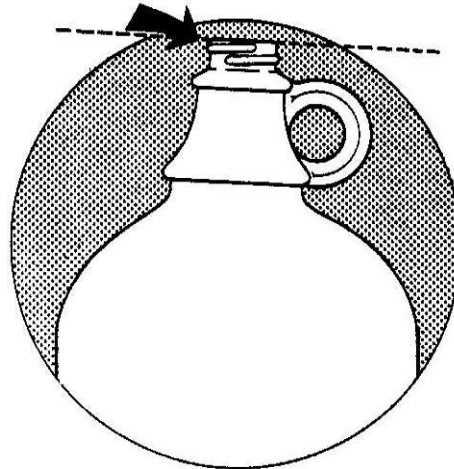
BENT NECKS

This defect is one in which the neck is out of line or not straight. It may cause trouble in a filling or capping operation and should be CORRECTED AT ONCE.

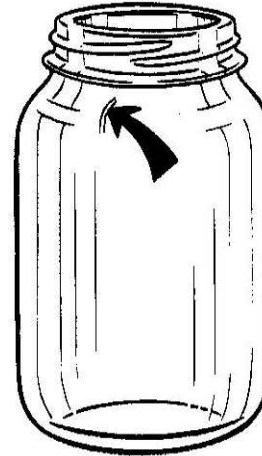
CHECKED SHOULDERS

A deep closed crack in the shoulder.
This should be corrected at once.

- a Too much final blow air
- b Bottom plate too high or too low
- c Blow head off before mold cracks
- d Takeout tongs too low, hitting shoulder
- e Blow head too tight on mold

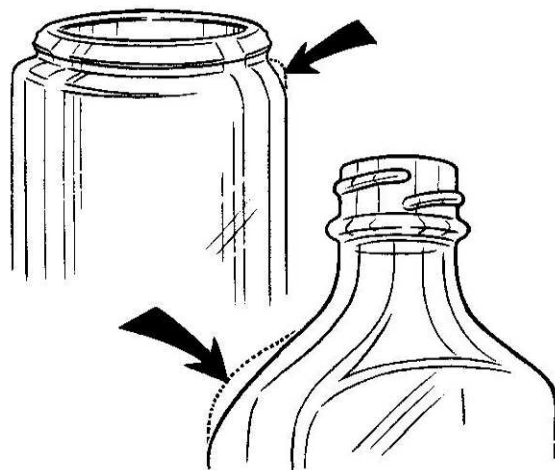
DOWN SHOULDERS

Shoulders that are not fully formed and do not completely conform to the shape of the mold cavity. This is usually caused by temperature conditions or molds not being properly vented. It results in bad appearance of the containers and may cause trouble to the customer's processing equipment. It may also cause under capacity.

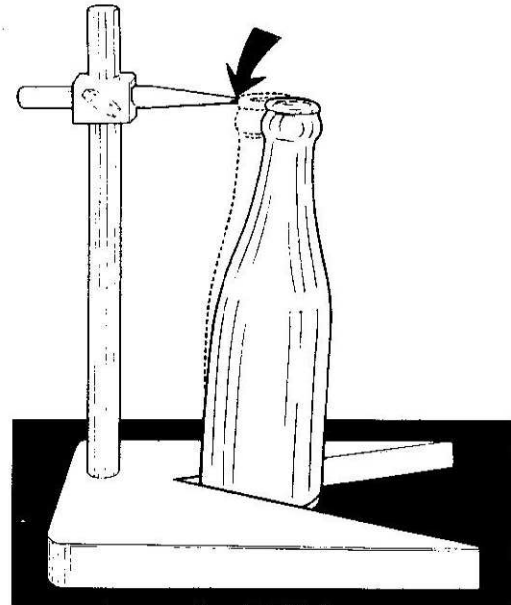
DEFECT DEFINITIONS AND CORRECTIONS**OUT OF SHAPE OR LEANER**

This is where the bottom of the bottle is not level. It may slope from either side, or the bottom surface may have waves in it. When they are too bad, they may cause trouble in washing, filling and labeling in our customer's plants.

- a Not enough wind on cooling pads
- b Not enough blowing time in mold
- c Bottle not hanging in takeout long enough
- d Too little final blow pressure
- e Pushout moving bottle to conveyor too soon

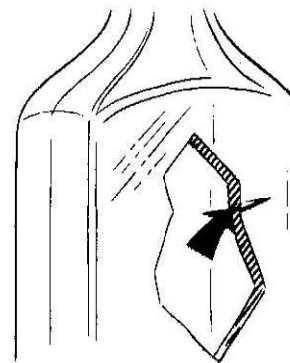
PRESSURE OR HOT CHECKS

This is a fracture in the wall of the bottle running from inside surface to the outside surface.

- a Too much final blow pressure
- b Improper wind setup
- c Final blow pressure on after mold cracks
- d Gob not loading in Blank correctly

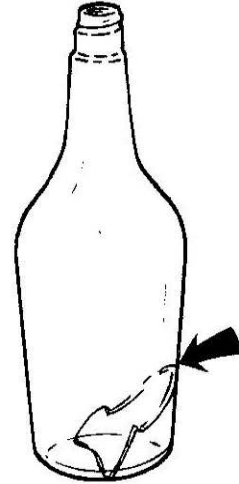
COLD CHECKS & LEHR BROKEN

The ware is completely broken on the lehr.

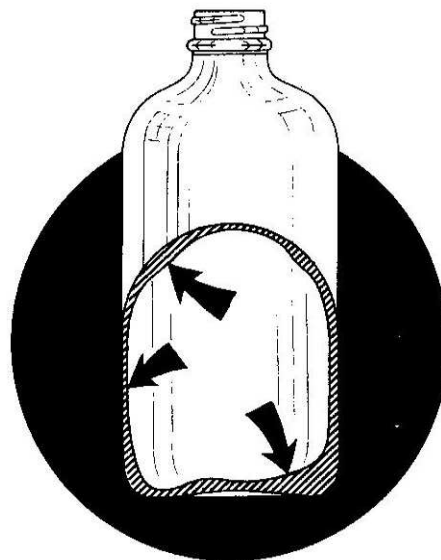
UNEVEN DISTRIBUTION

While it is commercially impossible to manufacture glass containers with a completely uniform distribution of glass and from a strength standpoint unnecessary, distribution must be maintained so as to avoid abnormal or below standard thin spots or sections.

- a Too short corkage reheat time (release plunger earlier)
- b Uneven wind control
- c Improper timing of glass entering machine
- d Too much settle blow time
- e Too little counter blow

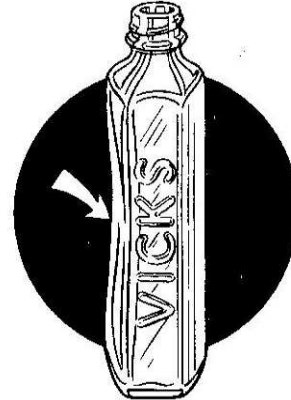
SUNKEN SIDES

The side of the bottle that is not fully blown up but sunken or dented. This may cause trouble in two ways. First, it may make the bottle under capacity and, second, it may cause trouble when our customers apply the label to the bottle.

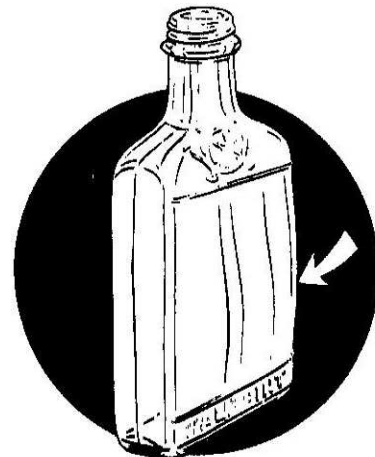
BULGED SIDES

Bulged sides are when the sides of the bottle are bulged or pushed out. This may cause trouble on our customer's filling lines by causing the bottles to hang up in the guides. It can also cause trouble on labeling machines and can be over capacity.

- a Too much wind on mold
- b Too little wind on cooling pad
- c Bottle not hanging in takeout long enough
- d Mold cracking before final blow releases

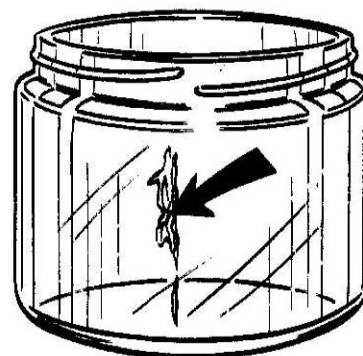
"STUCK" WARE

This condition is a pronounced rough edge of glass on the outside of the bottle.

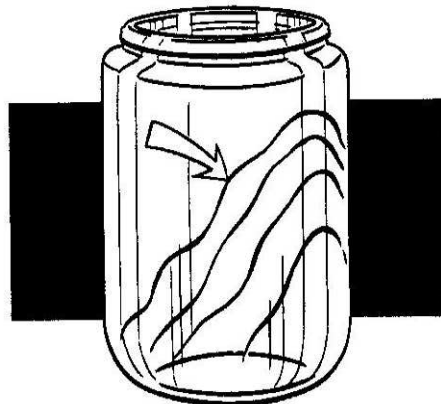
COLD MOLDS

This is a wavy and rough appearance in the body of the bottle.

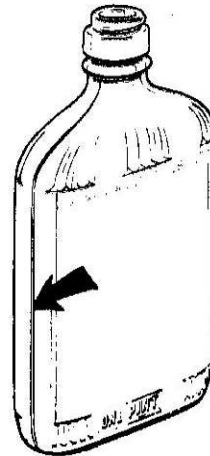
LARGE MOLD SEAMS

A pronounced rim or edge of glass standing out from the mold seam on the bottle.

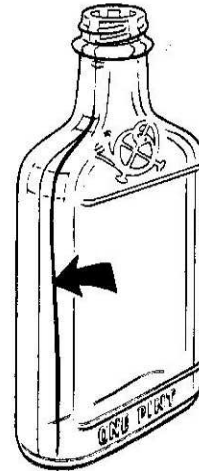
LARGE BLANK SEAM

An open scar on the bottle. It is easily seen and mostly an appearance defect. Mold seams are always straight, but blank seams (if they can be seen) tend to veer off from the mold seam.

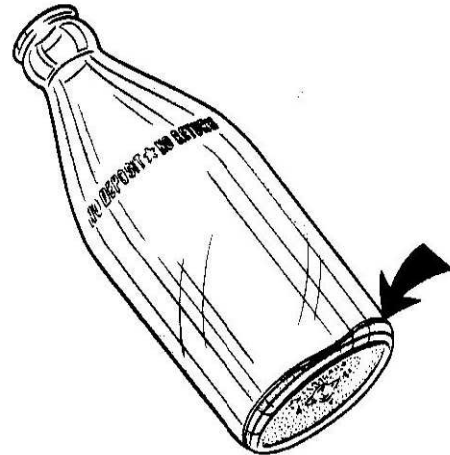
LAP LINES

These are long lines in the bottle caused by the glass overlapping.

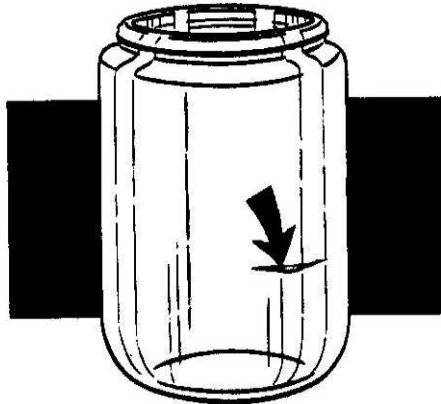
BODY MARKS

An open mark on the outside wall of the body of the bottle caused mainly by cold blanks and cold glass.

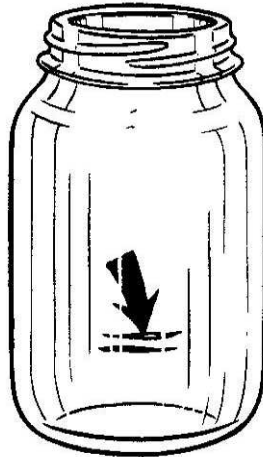
PLUNGER MARKS

An open mark on the inside wall of the body of the bottle on wide mouth ware. On narrow neck ware this mark is on the inside wall of the finish.

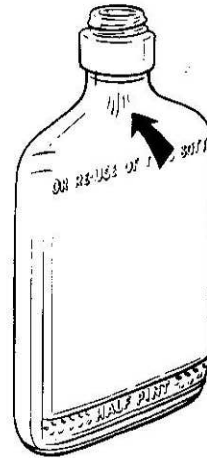
DRAG MARKS

These are rough appearing marks in the body or neck of the bottle.

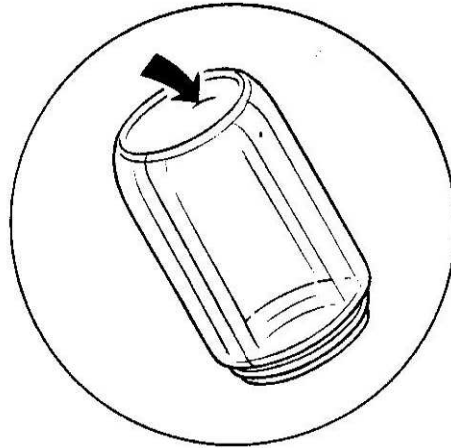
SHEAR MARKS

These are either oily marks due to the shear blades being dirty or V shaped marks due to dull blades or improper shear cam.

- a Not enough or too much shear lap
- b Shears not cutting centrally
- c Loose shears
- d Shears out of alignment
- e Cutting shear cam too slow

- a Worn or defective shear blades

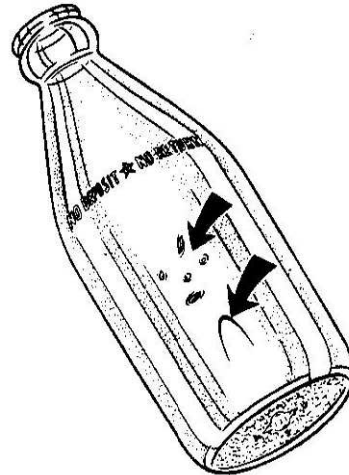
BLISTERS

Blisters are small air bubbles in the glass wall and are undesirable solely because they mar the appearance of the bottle.

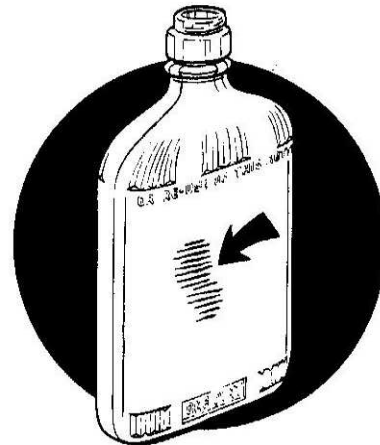
WASHBOARDS

These are horizontal marks on the bottle.

b Drop too small or improper shape
c Drop too large in diameter
d Drop too long

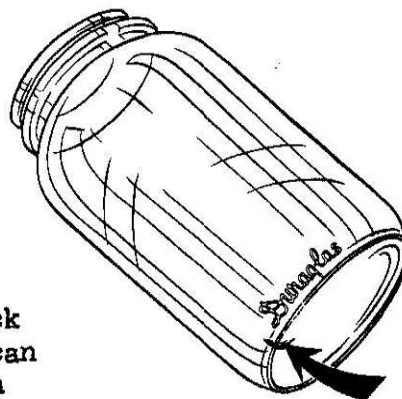
CHECKED BOTTOM

A checked bottom is a surface crack in the bottom of the bottle. It can be seen by catching the reflection of the light.

- a Too much final blow pressure
- b Bottom plate too high or low
- c Blow head off before mold cracks
- d Blow head set too tight on mold

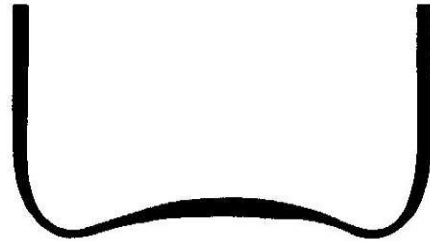
LIGHT BOTTOM

Light bottoms are similar to below
standard light or thin ware.

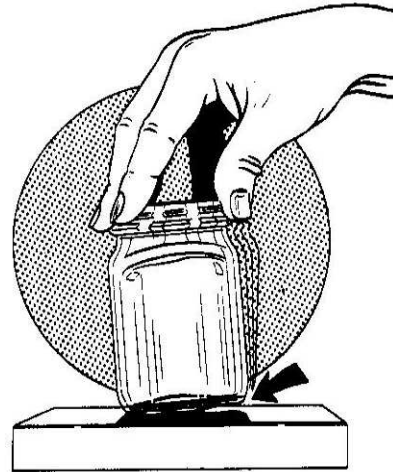
ROCKER BOTTOM

This defect gets its name from the fact that the bottle will rock when it is placed on a level surface. It is a condition in which the center of the bottom is lower than the outside rim of the bottom.

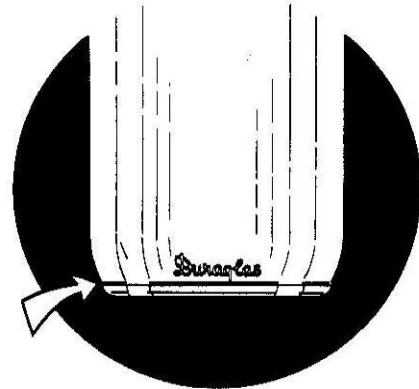
FLANGED BOTTOM

A flanged bottom is a flange or rim of glass running around the bottom of the parting line of the body and bottom molds. Flanges can be chipped or may cause the bottom to break.

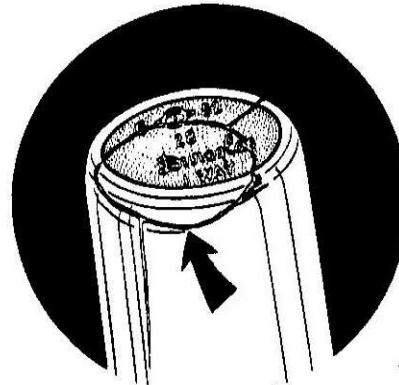
SWUNG BAFFLE

Heavy baffle marks are scars on the bottom of the bottle. Swung baffle is when the baffle match is swung to one side and is not centered on the bottom.

- a Pattern reheat too short
- b Too much counter blow or plunger press
- c Gob not loading deep enough
- d Blank and baffle need swabbing
- e Plunger press after blank cracks
